# ORPHANED WELL PLUGGING AND RESTORATION

EXHIBIT 5  
DATE 1/24/07  
HB 7

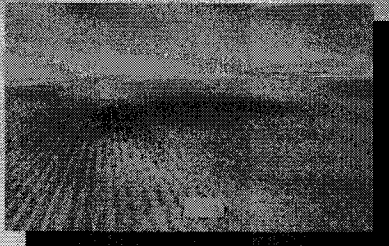
**Before:** State #1 Sec. 16, T34N, R1W

An orphaned gas well is leaking in a cultivated field.

**PROBLEM:** An exposed orphaned well, leaking natural gas, killing the crops in a cultivated field.

**SOLUTION:** Reopen the old casing and plug the well properly with cement; restore the surface to its previous productive condition.

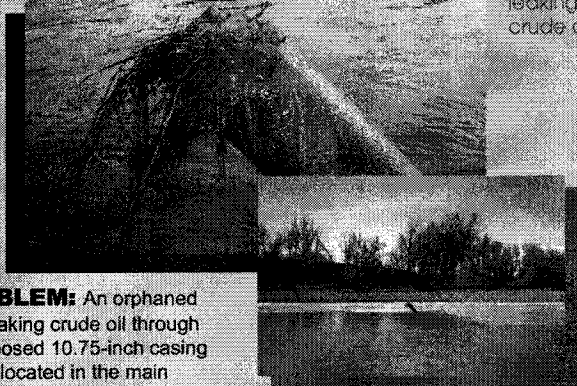
**Before:** Van Winkle #1 Sec. 23, T2S, R24E Surface casing is sticking up in the Clarks Fork Yellowstone River and leaking crude oil.

**PROBLEM:** An orphaned well leaking crude oil through an exposed 10.75-inch casing that is located in the main channel of the Clarks Fork Yellowstone River.

**SOLUTION:** Build a temporary island in the river as a work site for corrective action, with approvals from the appropriate governmental agencies.

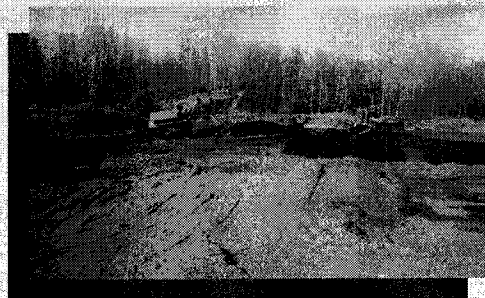
**Operations:** With a temporary work pad in place, the board moved a work-over rig on-site, cleaned the well casing to the appropriate depth, and plugged the well with mechanical and cement plugs.

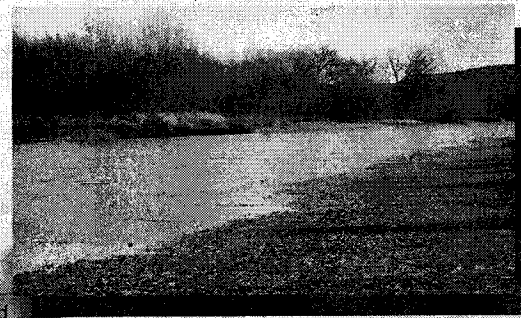
**After:** Van Winkle #1 is plugged, and the location is restored to its previous condition.
